Linwood Lake Carp Management Feasibility Assessment

Prepared for the Sunrise River WMO

June 12, 2020

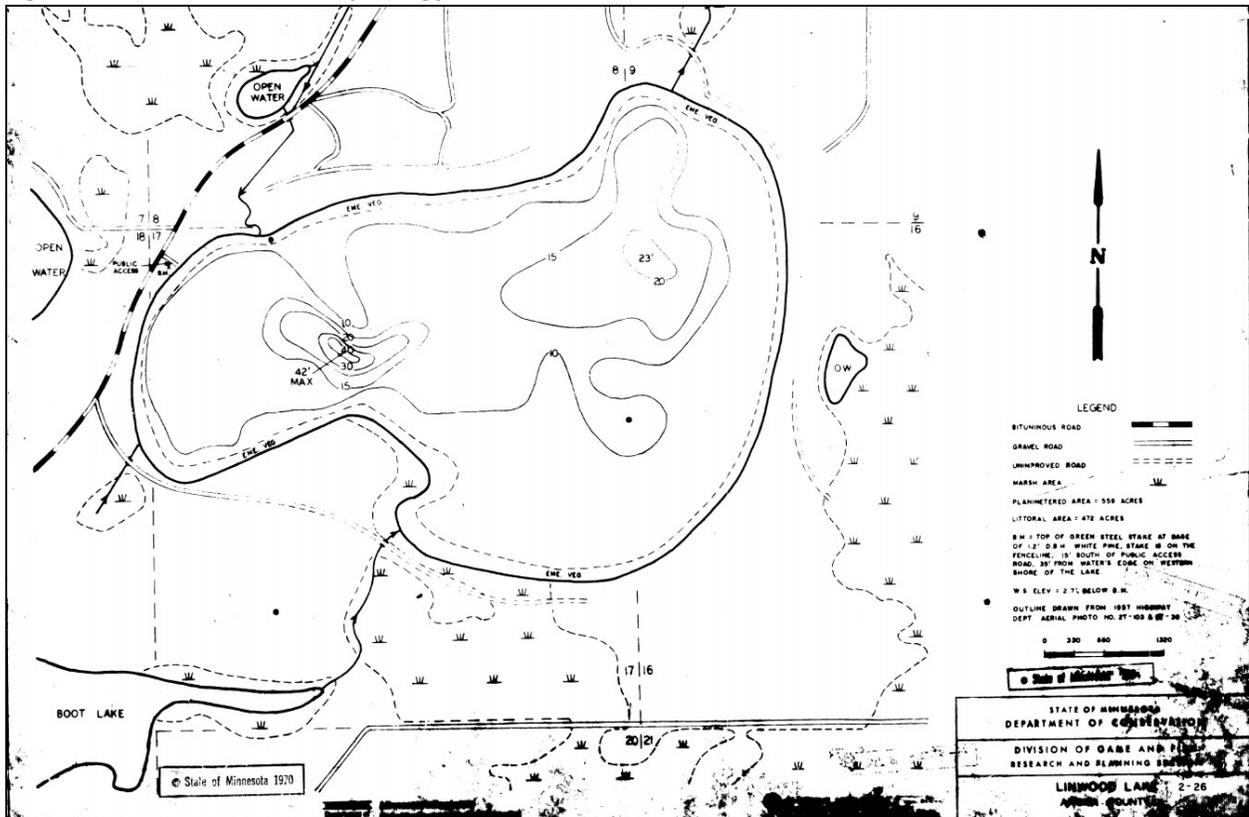
Figure 2 – Linwood Lake morphology. Source: MN DNR.

Linwood Lake is 569 acres. It has a maximum depth of 42 feet and mean depth of 9.2 feet (

Figure 2). 85% of the lake is littoral.

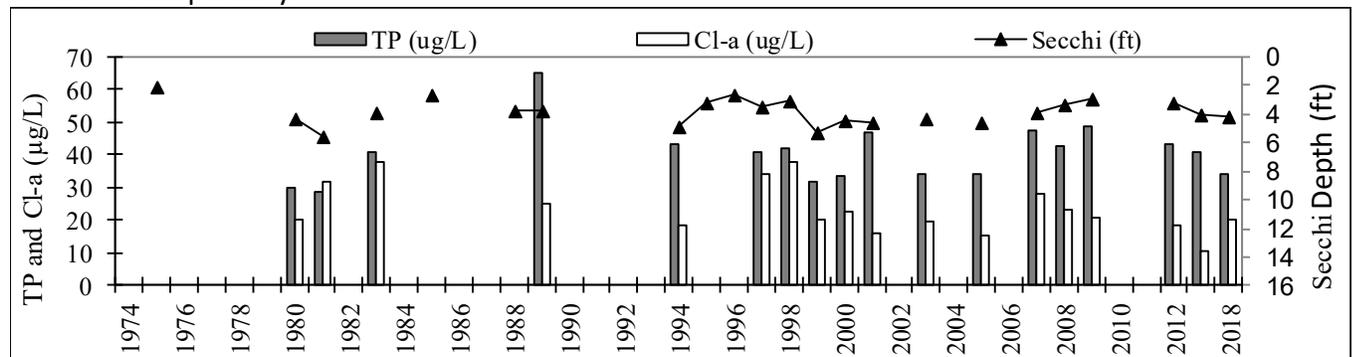
Figure 3 – Linwood Lake historic water quality. TP = total phosphorus. Cl-a = Chlorophyll-a. Secchi = transparency.

Eighteen years of water quality data have been collected by the Metropolitan Council (1980, '81, '83, '89, '94, '97, and 2008) and the ACD (1998-2001, 2003, '05, '07, '09, '12, '15, and '18). Water quality has not significantly changed from 1980 to 2018 (repeated measures MANOVA with response variables TP, Cl-a, and Secchi transparency; $F_{2, 15}=2.74$, $p=0.10$).

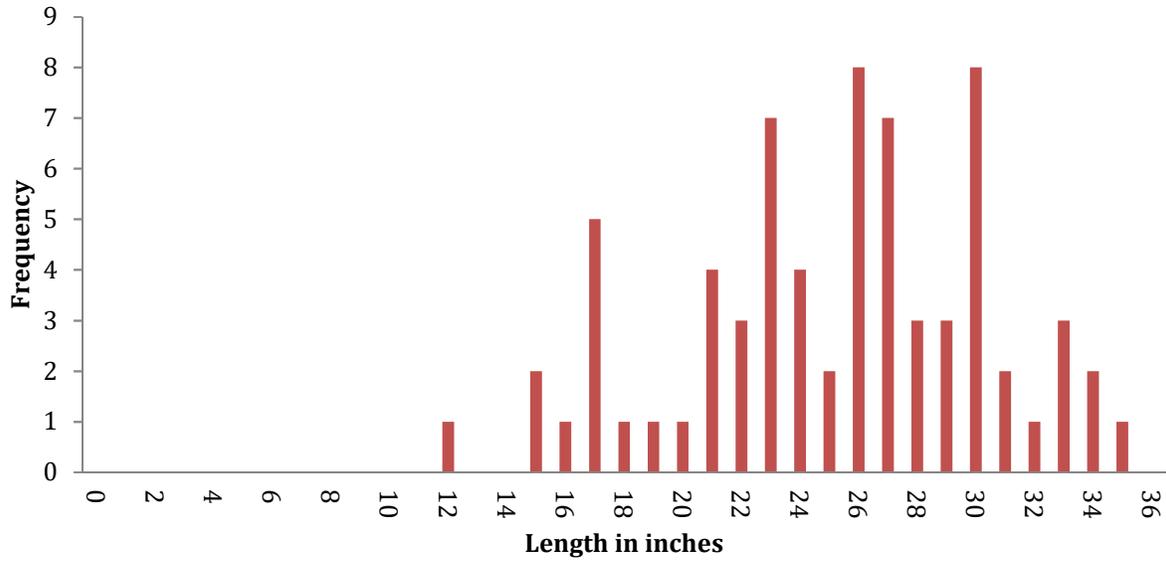
Figure 4 - Length distribution for carp captured during electrofishing surveys.

Table 3). This catch rate suggested that Linwood Lake was inhabited by approximately 9,851 carp. Their lengths ranged from 300 mm to 877 mm (Figure 4). Using the mean length (24.7 in) and weight (3.2 kg or 7 lbs), the surveys suggested that the biomass of carp in Linwood Lake was 110 kg/ha, or 98 lb/ac (Table 4). The management goal for carp in lake ecosystems is 100 kg/ha or 89 lb/ac (Bajer et al. 2009), thus common carp biomass appears to be marginally above this threshold.

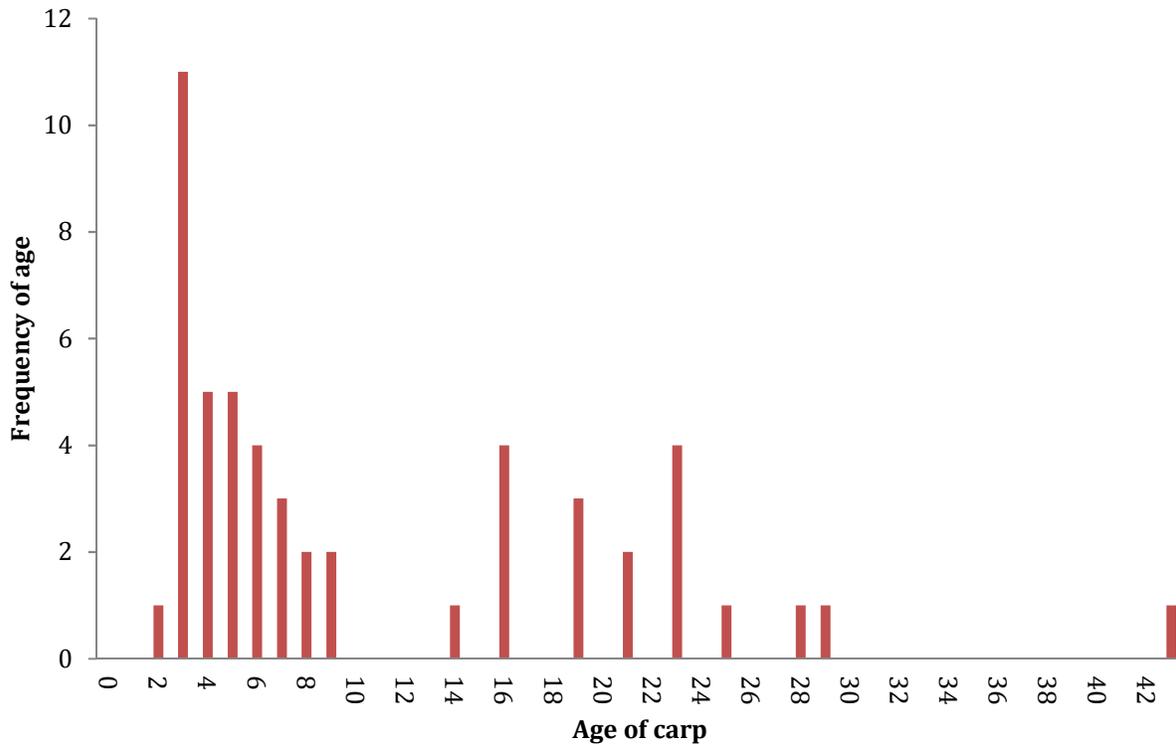
Figure 5 - The age structure of a sample of carp (n=51) analyzed from Linwood Lake.

Aging analyses show that the population of carp in Linwood Lake appears to be relatively young. They range from two to 43 years old (Figure 5). A large portion (65%) of the sample was spawned within the last decade with the biggest spike only three years ago. One third of the sample was spawned about every two years between 14 and 29 years ago.

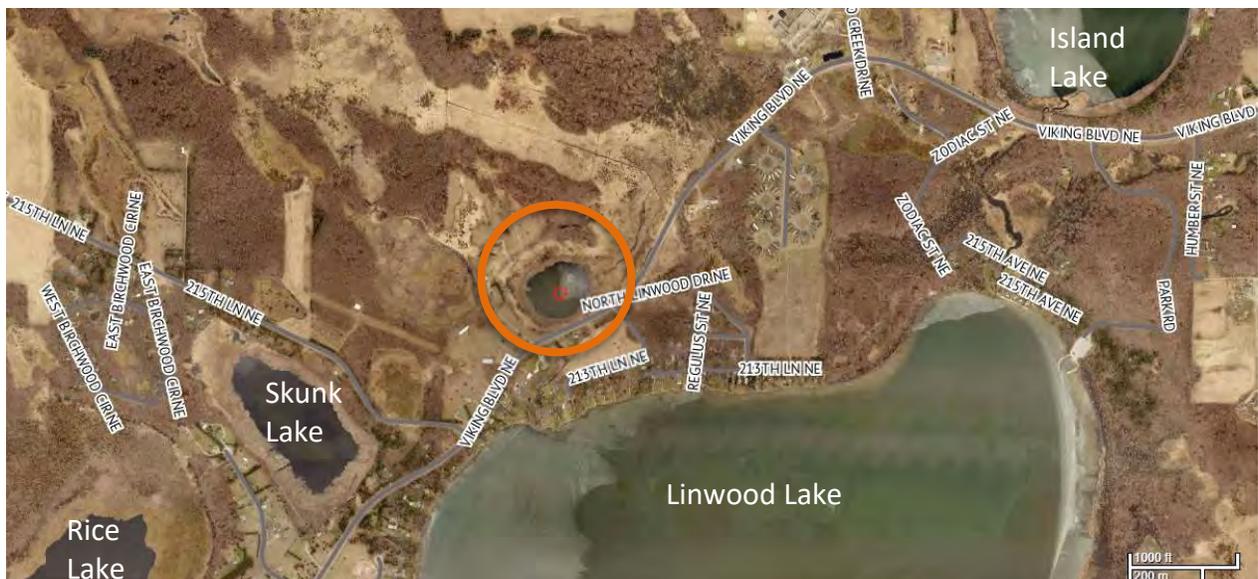
Figure 6 – Location of pond (circled) within DNR Aquatic Management Area identified as a possible nursery area but not trap netted.

Skunk or Rice Lake appear to be possible nursery areas for Linwood Lake carp, but were not surveyed (Figure 6). Skunk Lake is isolated, with no inlet or outlet and was therefore not surveyed. Rice Lake is hydrologically connected to Linwood Lake and should be included in future surveys.

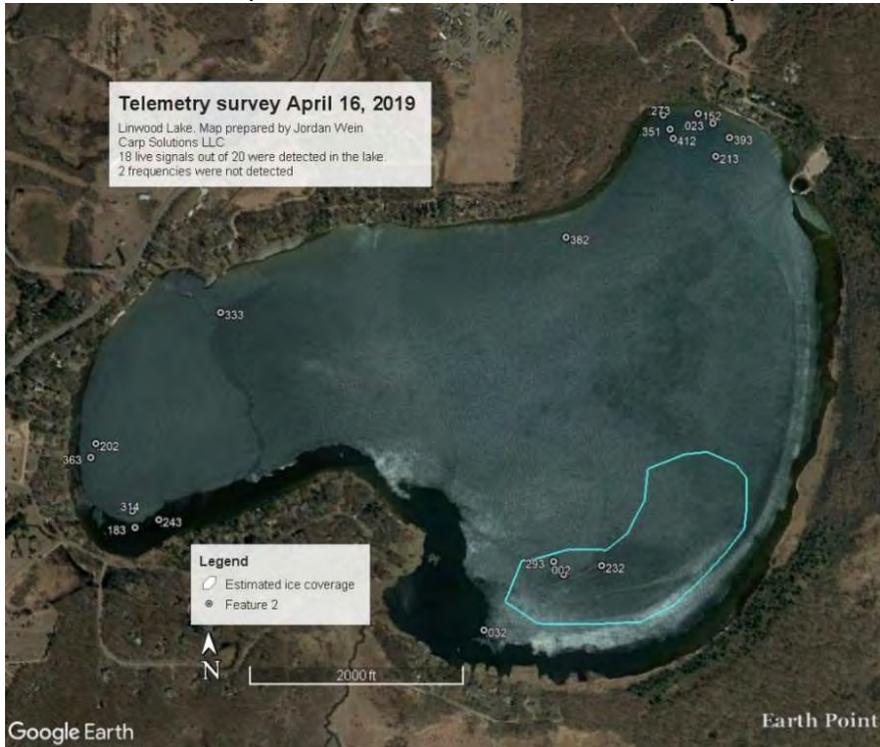
May 21, 2019: 18 of the 20 tagged carp were located in Linwood Lake. All signals were live. The remaining two carp (265 and 372) were not heard. In addition to checking Linwood Lake from a boat, Boot Lake, Island Lake, and the DNR Aquatic Management area next to Viking Blvd NE were checked from the road. No signals were heard at these locations.

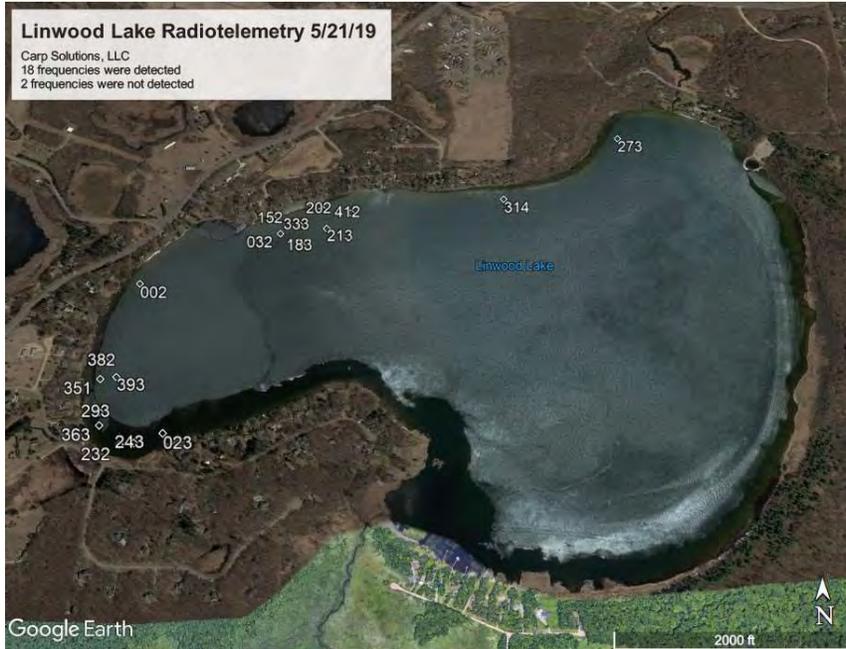
February 21, 2020: A radio telemetry survey was conducted on Linwood Lake on February 21, 2020. Of the 20 radio tagged fish, 13 were located in the lake, one being a mortality signal. 11 of these carp were aggregated in the northeast corner of the lake. Boot Lake, Island Lake, and the DNR Aquatic Management Area (AMA) located next to Viking Blvd NE were also checked. In Island Lake, 3 live carp were heard. There were no signals heard at the pond or Boot Lake. A total of 4 tagged carp were not found (412, 351, 152, & 372).

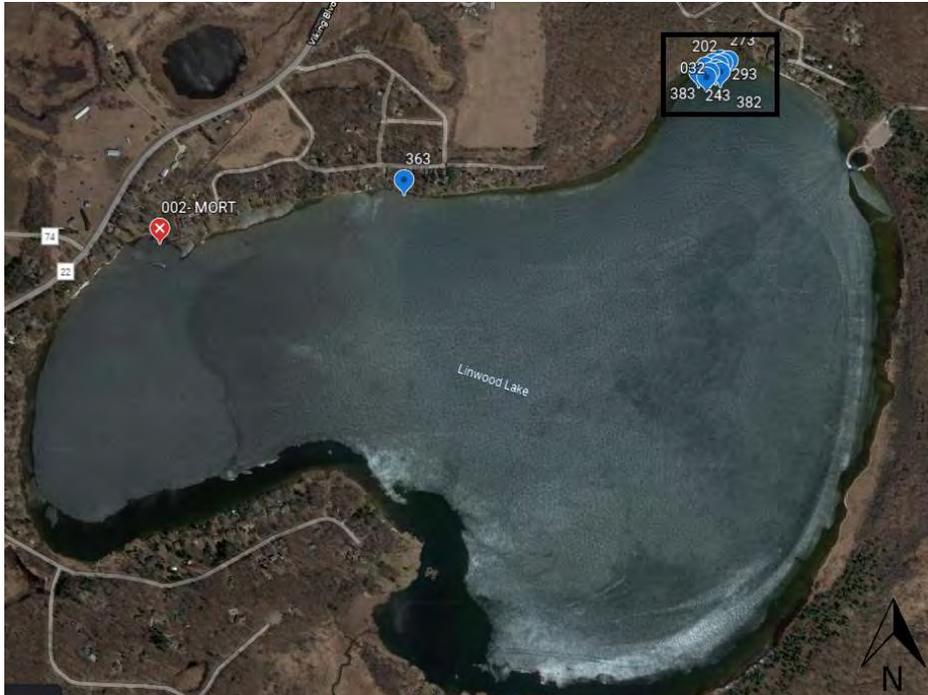
February 21, 2019 carp tag numbers found: 333, 032, 202, 232, 265, 243, 293, 273, 382, 023, 393, 363, and a mortality signal for 002.

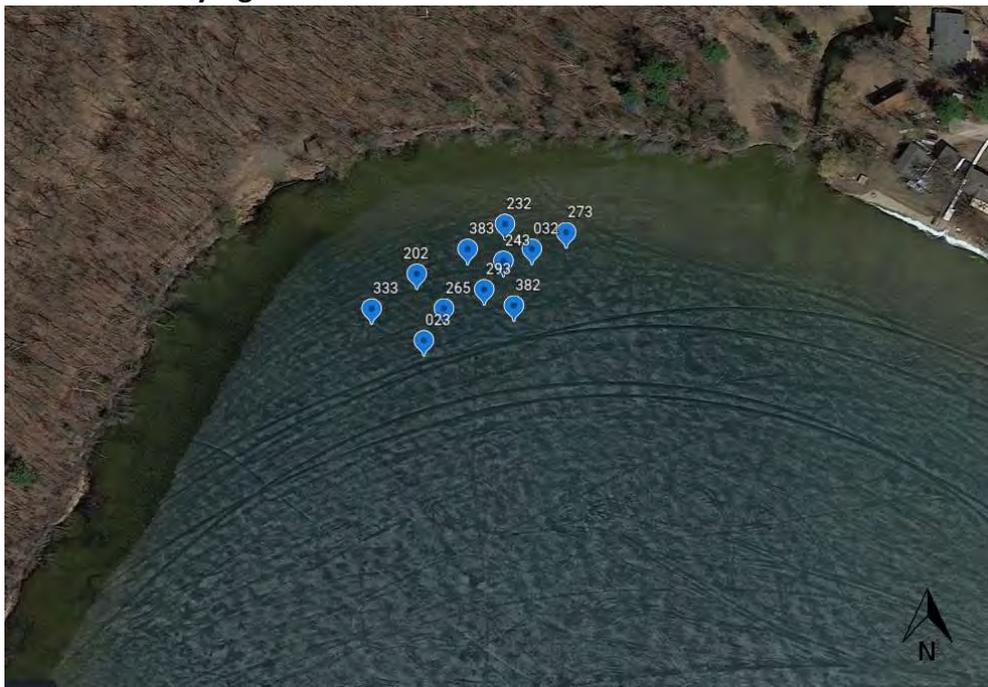
February 21, 2019 carp aggregated in the NE corner in Linwood Lake, inset map.

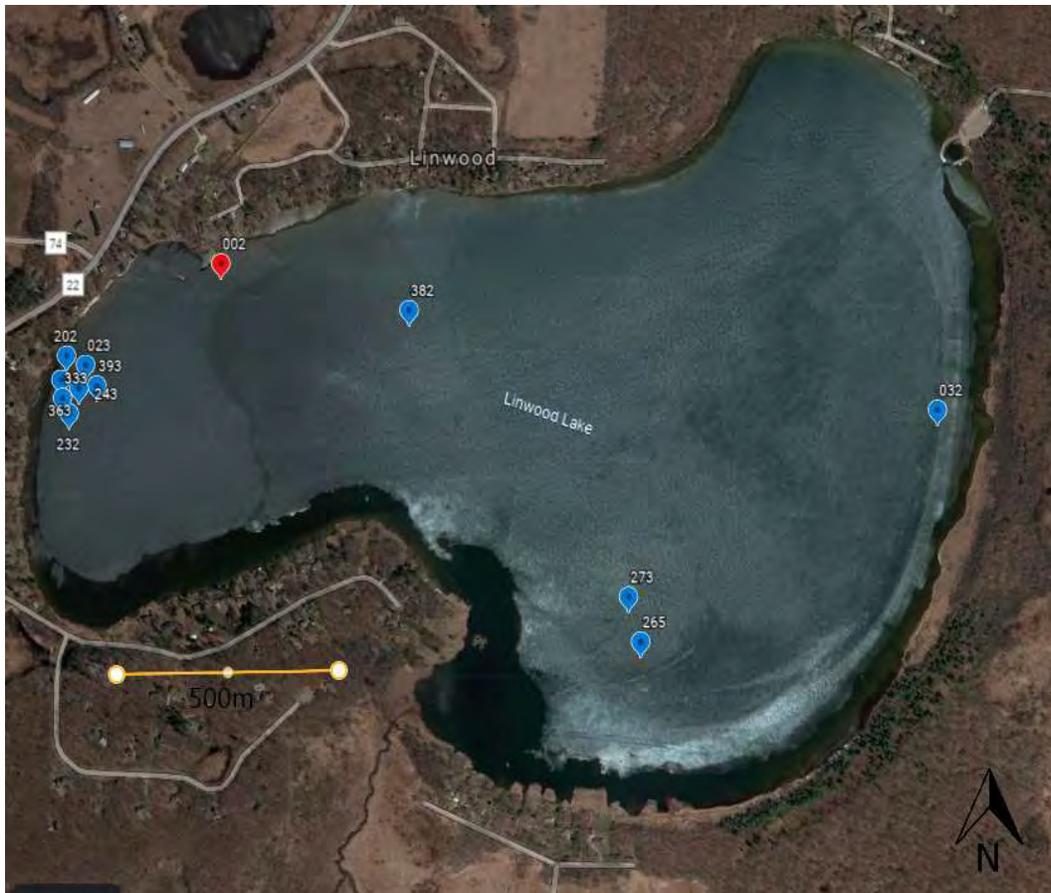
April 14, 2020 carp map. Tag numbers found: 265, 023, 363, 393, 382, 032, 333, 243, 232, 202, 273, and a mortality signal for 002.

April 14, 2020: A radio telemetry survey was conducted on Linwood Lake on April 14, 2020. During the survey Linwood and Island Lake were checked from boat, as well as Boot Lake and DNR Aquatic Management Area along Viking Blvd NE from roadside. 12 tagged carp were located in Linwood Lake, and 3 were located in Island Lake. 5 tagged carp were not heard at any location (293, 412, 351, 152, & 372).

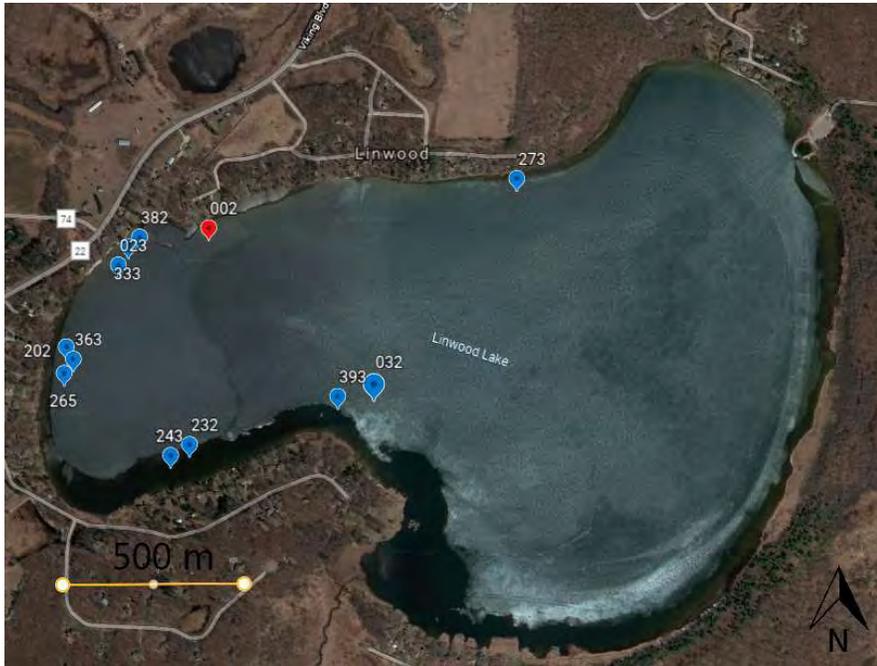
May 6, 2020 tag numbers found in Linwood Lake: 265, 023, 363, 393, 382, 032, 333, 243, 232, 202, 273, 293, and a mortality signal for 002.

May 6, 2020: A radio telemetry survey was conducted on Linwood Lake on May 5, 2020. During the survey Linwood and Island Lake were checked from a boat in the lake. In addition, Boot Lake, Martin Lake, and the DNR Aquatic Management Area along Viking Blvd NE were scanned from roadside. 13 of the 20 tagged carp were located in Linwood Lake, 3 were located in Island Lake, and 2 were heard in Martin Lake. The tagged carp that were in Island Lake have been heard there since February 21, 2020. The 2 carp that were found in Martin Lake were heard from the boat launch (152 & 351). There were no other carp heard at the other roadside locations. 2 of the 20 carp were not found (372 & 412). These 2 carp and the additional 2 that were found in Martin were last located in Linwood Lake in May 2019. They were not found in

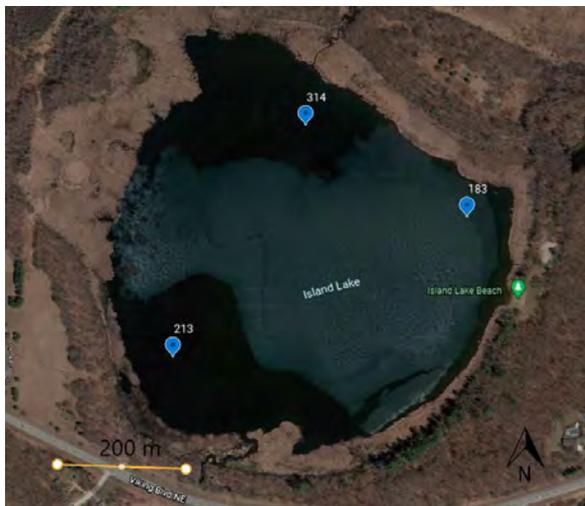
May 6, 2020 carp located in Island Lake. Fish tag numbers found: 213, 182 & 314.

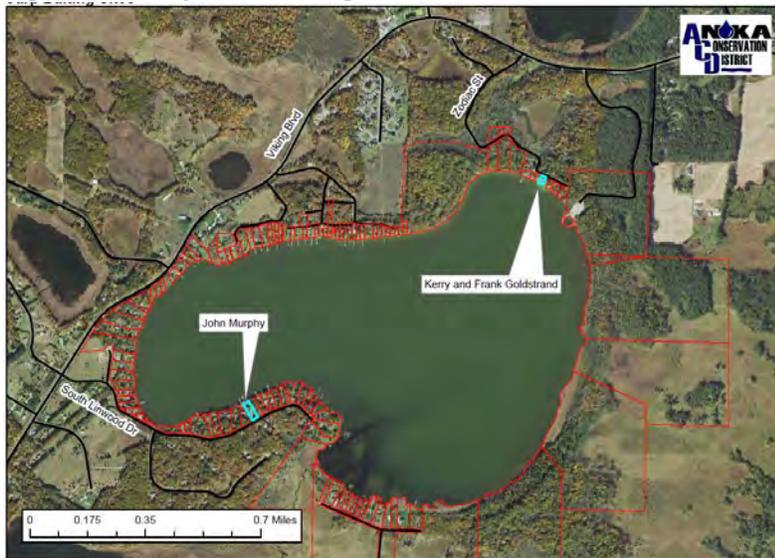
Figure 7 – Carp test baiting locations.

Carp were baited at two locations by volunteers (Figure 7). The locations were places where radio tracking had shown carp sometimes congregate. A mesh laundry bag with cracked corn bait was placed in the lake in 2-3 feet of water. Corn consumption was tracked daily.

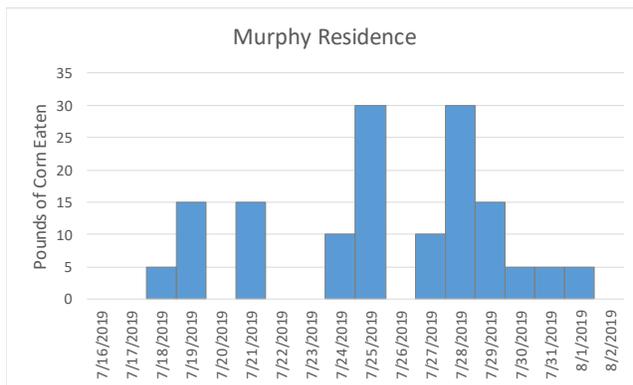
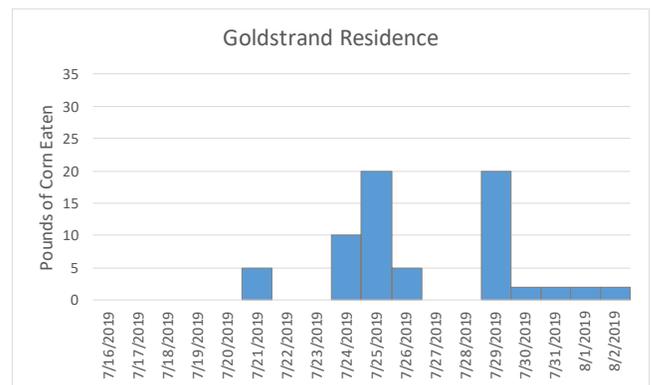
Figure 8 - Corn consumption during test baiting.

Carp in Linwood Lake ate the corn only intermittently and at lower levels that would be desired for box netting. They did eat up to 30 lbs per night and created “craters” where they rooted around the bait bags. However, there were many nights with 5 or fewer pounds of corn eaten.

Timing may have been one reason the carp did not respond in large number to the test baiting. July 2019, when test baiting occurred, has been an effective month for carp removals at other nearby lakes in the past. But even at those other lakes with four-times the carp density, July 2019 had lackluster carp feeding. Late August or September has historically been the best time for carp baiting/netting at other lakes.

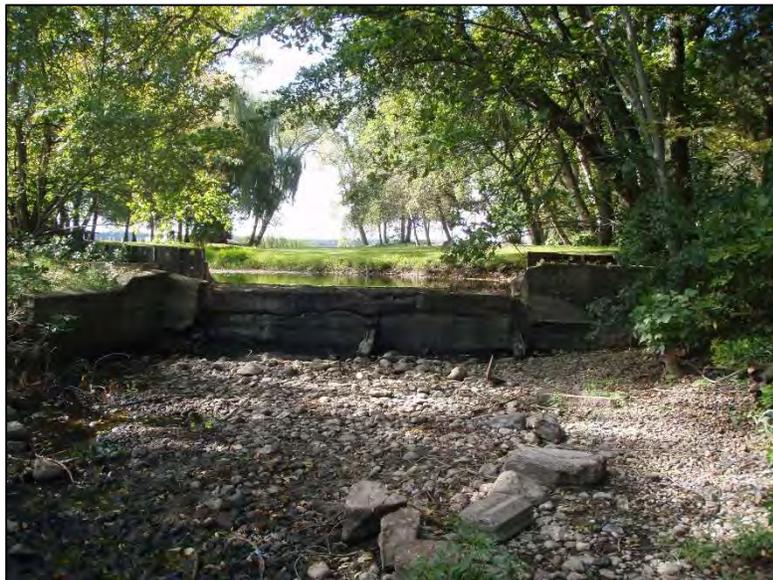
Figure 9 – Linwood Lake outlet. Shown during low water conditions with no lake discharge.

Linwood Lake outlets toward Island Lake via a low head weir (Figure 9). Carp could traverse this structure, particularly in high water. Residents have not described seeing carp congregating near it. In 2019 at least five carp tagged in Linwood Lake went to Island Lake. Two of those continued to Martin Lake.

- **Consider a carp barrier at Linwood Lake outlet.** The outlet is in disrepair. When repaired or replaced, a design that prevents carp movement is recommended.
