# GUSTAFSON LAKESHORE RESTORATION WYOMING, MN

## Project Summary

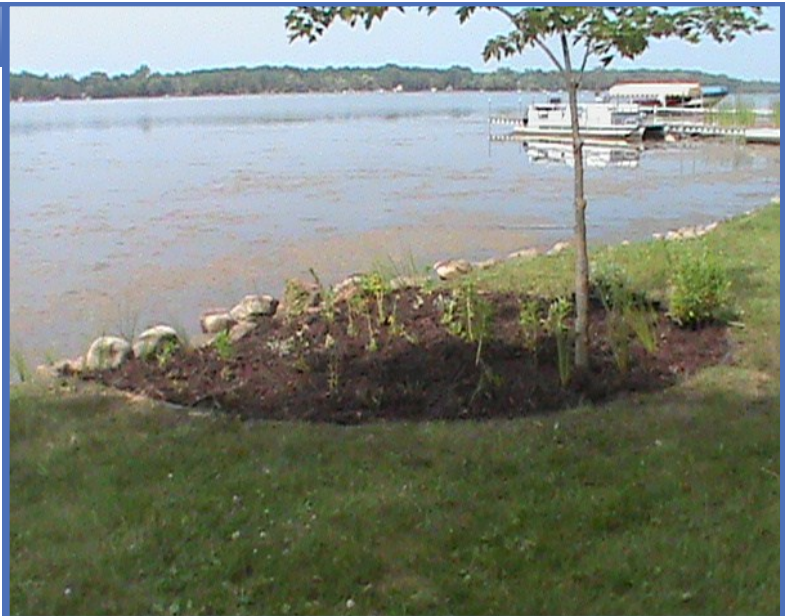
Completed project in the summer of 2012.

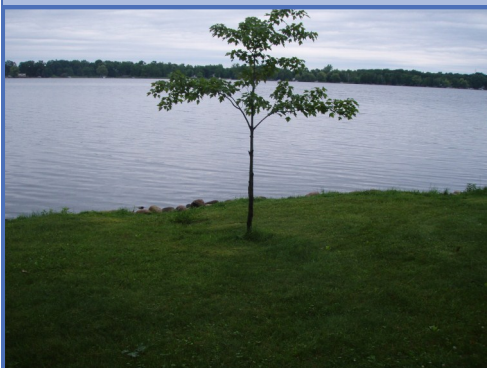
Pre-restoration conditions consisted of mown turf grass and Creeping Charlie, which provided no benefits to water quality, wildlife habitat, or shoreline stability.

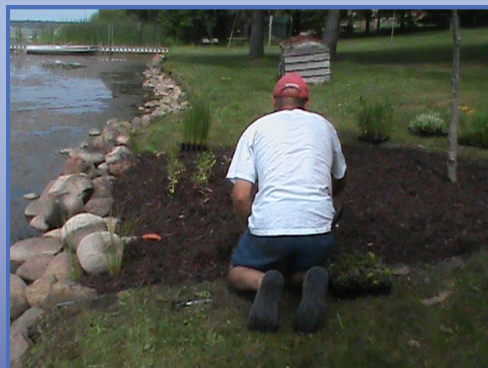
Sod was removed prior to the installation of erosion control blanket, shredded hardwood mulch, landscape edging, and native plant plugs.

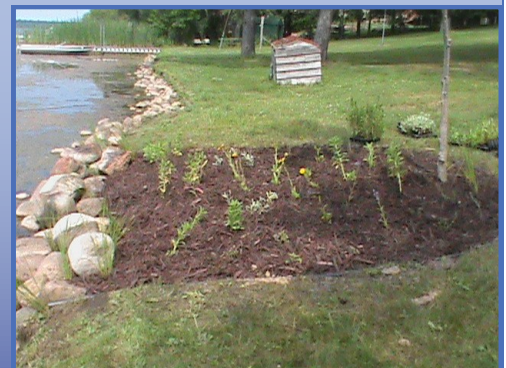
These practices will benefit habitat and water quality. In addition, the elaborate root system of the established native plant community will increase shoreline stability.
