2022 Annual Report

East Bethel – Ham Lake – Linwood - Columbus

APRIL 3, 2023

Chapter 2: Sunrise River Watershed

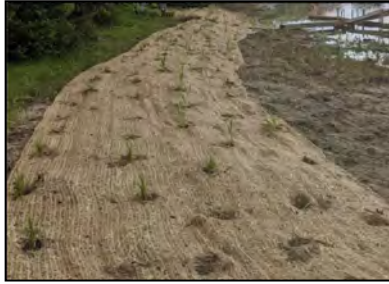
Lakeshore Projects (2022)

Completed lakeshore restorations at Fawn, Linwood, & Martin Lakes, with a total 330 linear ft of shore stabilized & 4,720 sq ft of native plants installed.

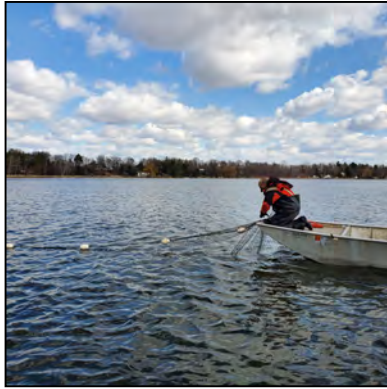
Sunrise River Chain of Lakes Carp Project (2017-2022)

Multiple grants have funded carp management in the chain of lakes including Linwood, Martin and Typo. The project installed four carp barriers and removed 14,517 carp resulting in water quality and habitat improvements. Harvest methods included box netting and seining. “Maintenance” box netting is planned in 2024. Partners include the Anoka Conservation District, SRWMO, Martin Lakers Association and Linwood Lake Improvement Association.

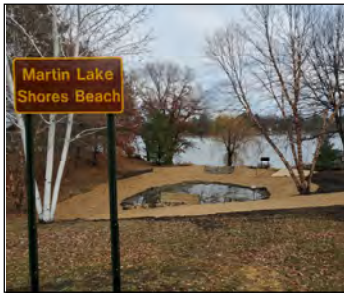
Martin Lake Shores Park Stormwater Pond Enhancement (2021)

An existing stormwater pond treating water draining to Martin Lake was enhanced. The pond footprint was increased 55% and depth doubled to achieve greater pollutant reductions from a 41 acre drainage area.

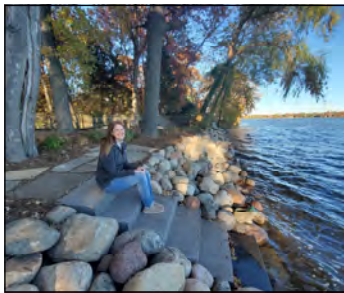
Martin Lake Shoreline Stabilization at 22865 W Martin Lake Dr (2021)

Prior to the project, the lakeshore was a failing mix of concrete and railroad tie retaining walls, & mowed turf grass. Retaining wall debris was removed, the shore graded to a stable slope, and rock rip rap installed. A 612 sq ft vegetated buffer of native plants was installed. The project benefits Martin Lake water quality and near shore habitat.

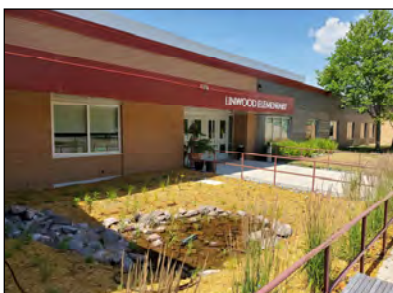
Linwood Elementary School Rain Garden (2021)

This project corrected poor drainage and appearance in an existing rain garden while serving as a demonstration project and educational opportunity.

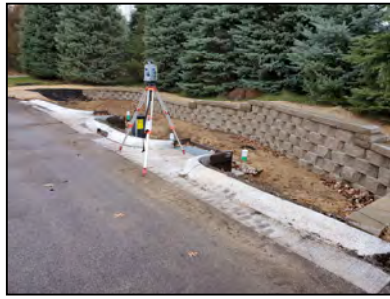
4471 Channel Lane Rain Garden for Coon Lake (2020)

A double-inlet curb cut rain garden was installed at a private residence that treats stormwater from 7.85 acres of the neighborhood. It captures and infiltrates water that would otherwise be directly discharged to Coon Lake without treatment.

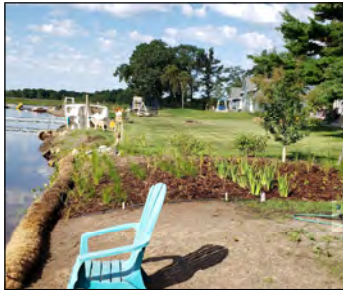
Coon Lakeshore Restoration (2020)

A private lakeshore at Coon Lake had 41ft stabilized and 877 sq ft restored with native vegetation. The project filters runoff to benefit water quality and provides near-shore habitat.

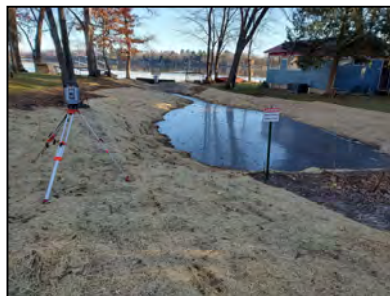
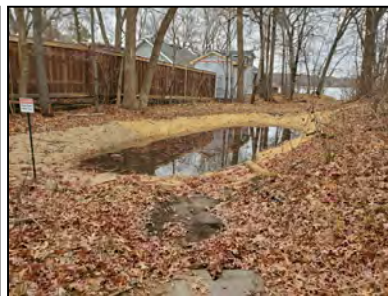
228th Lane and 230th Ave Stormwater Pond Enhancements (2019)

Two stormwater ponds were renovated along West Martin Lake Dr. in Linwood Township. This renovation made them larger and deeper. These stormwater ponds will now be more effective at treating stormwater being discharged into Martin Lake.

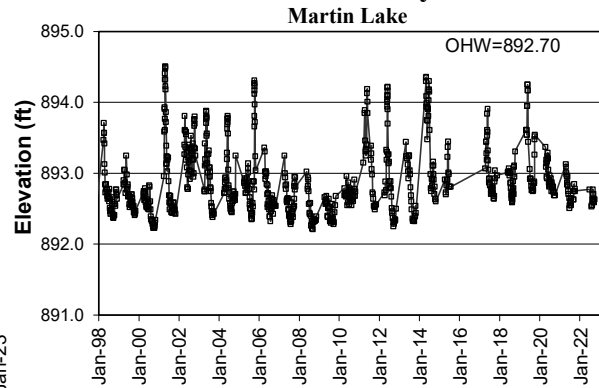
Martin Lake – last 5 years

Individual lakes varied. Typo and Martin Lake water levels fluctuated between similar ranges to previous years and had similar averages, with a slight increase compared to the previous 2-years of monitoring. Fawn, Coon and Linwood Lake seemed to be more affected by the drought conditions. Coon Lake observed its lowest water level since 2009 and has only had lower water levels in 1988, 1990 and 2000. Coon Lake also had its lowest average since 2010. Fawn Lake recorded its lowest water level on average since 2013. Linwood Lake water levels averaged higher in 2022 than the previous year but 2021 observed the second lowest recorded water level ever, the record low being observed in 1988.

Lake	Year	Average	Min	Max
Martin	2018	892.85	892.59	893.31
	2019	893.32	892.75	894.25
	2020	892.95	892.69	893.37
	2021	892.77	892.51	893.13
	2022	892.83	892.53	893.51

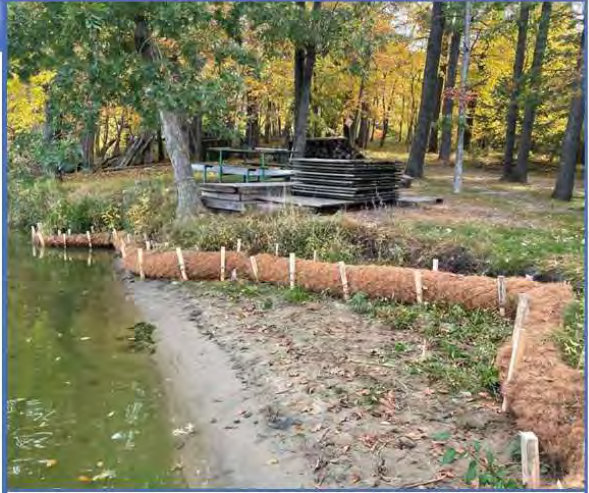
This project stabilized 70 linear feet on Martin Lake, which is a state impaired water and priority for the local watershed organization. Funding was from the landowner and the ACD cost-share program. ACD provided project administration, design services, and project installation.

Biolog installation. October 2022.

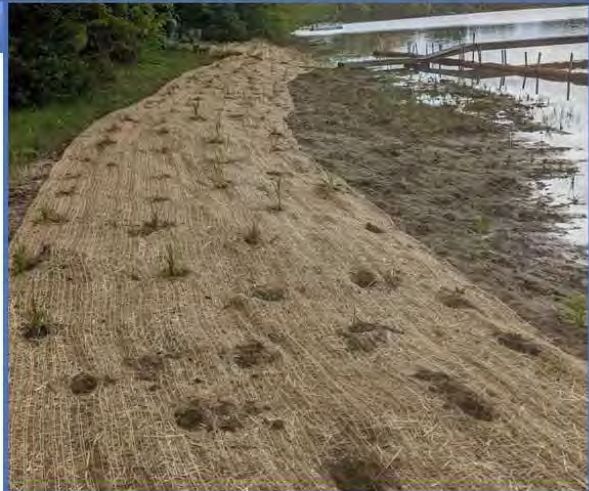
200 linear feet of shoreline was stabilized and planted. Coir (coconut fiber) logs were installed along shore. The logs provide protection from wave erosion, while the shoreline becomes fully vegetated. Thereafter, the plants provide shoreline protection. Above the waterline, the area was seeded with a native plant mix and supplemented with native plugs. The planting area was approximately 4,000 sq ft.

Project area. Installed July 2022.

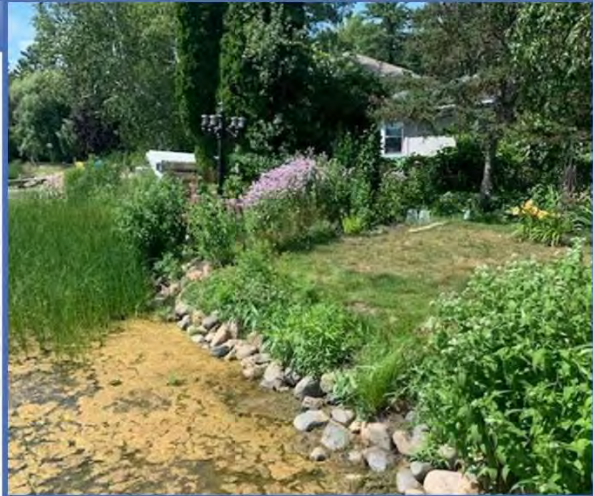
This project planted an area of approximately 720 sq ft. The owner removed sod, installed plants and is maintaining the plantings. ACD provided project administration and design services.

Shoreline after planting, July 2022.

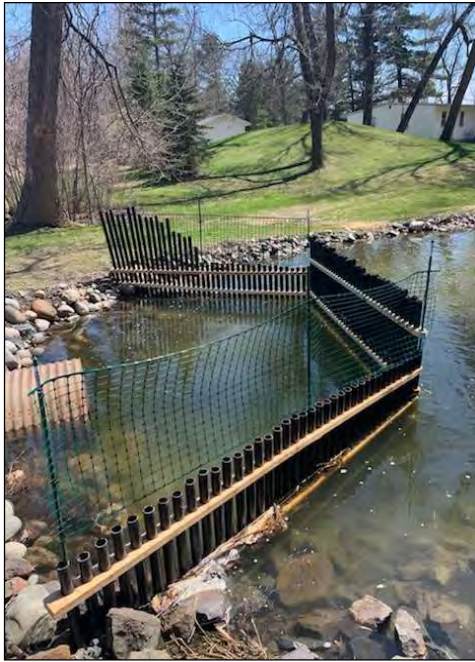
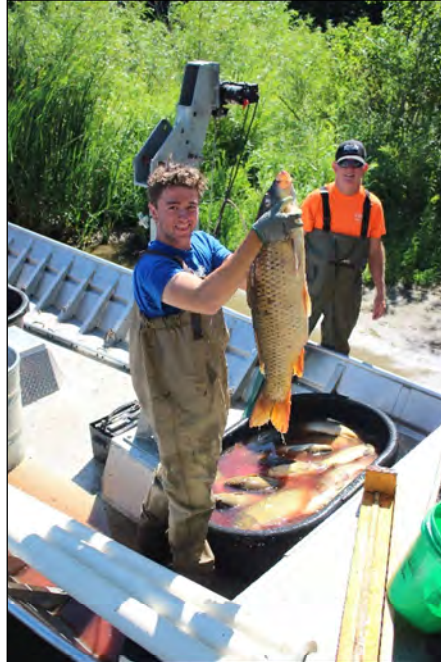
Left: Temporary carp barrier at Linwood Lake outlet.

Right: July 2022 carp box netting at Martin Lake.
